**Flood Control Project Maintenance
Levee Inspections**

2019 Channel Summary Report

Adin Community Service District

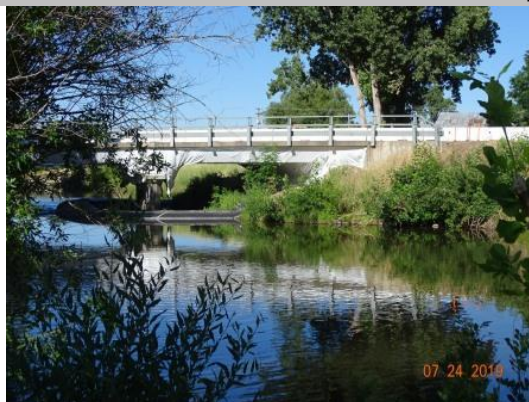
Photo 1 of 1 : CH_2019_NA0030_1_1_20190726_00008.jpg

View of the Ash Creek upstream of the Highway 299 bridge.

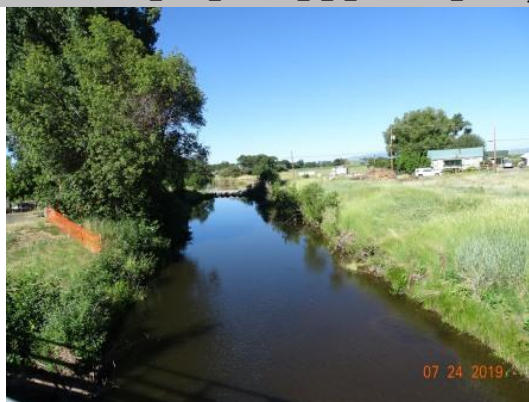
Photo 1 of 1 : CH_2019_NA0030_1_6_20190726_00009.jpg

Downstream view of Ash Creek from the Highway 299 bridge.

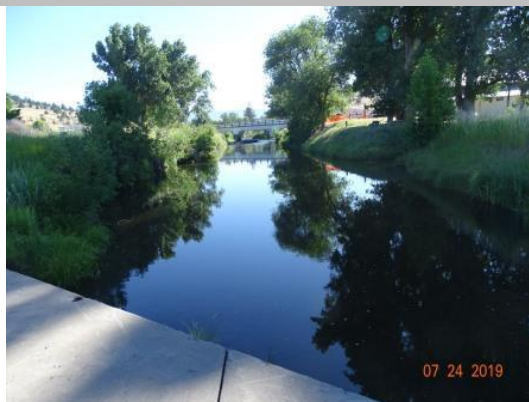
Photo 1 of 1 : CH_2019_NA0030_1_11_20190726_00010.jpg

Upstream view of Ash Creek from the Ash Street crossing.

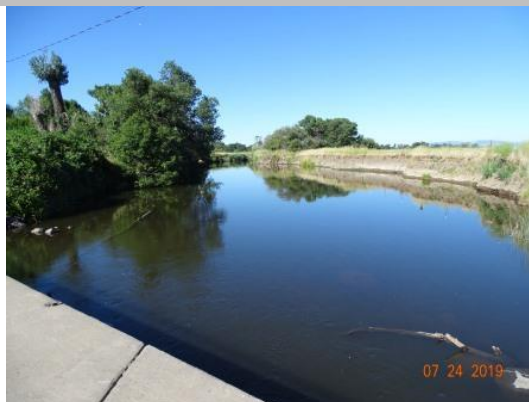
Photo 1 of 1 : CH_2019_NA0030_1_16_20190726_00011.jpg

Downstream view of Ash Creek from the Ash Street crossing.

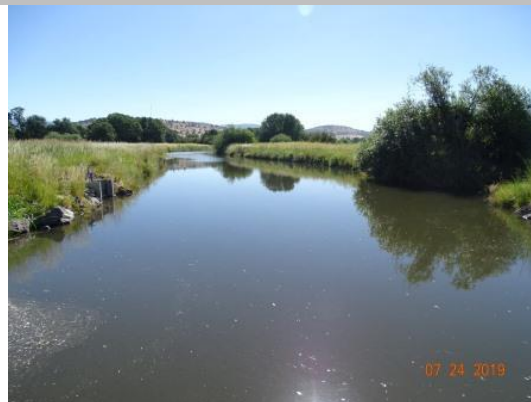
Photo 1 of 1 : CH_2019_NA0030_1_31_20190726_00012.jpg

Upstream view of Ash Creek from the weir.

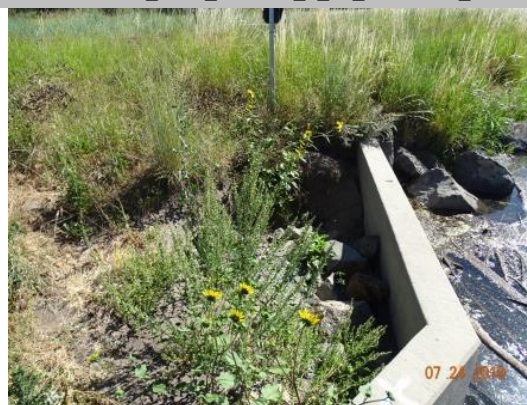
Photo 1 of 1 : CH_2019_NA0030_1_33_20190726_00014.jpg

Inspector Comments: There is minor erosion along right side of the structure.

View of the erosion along the right side of the weir.

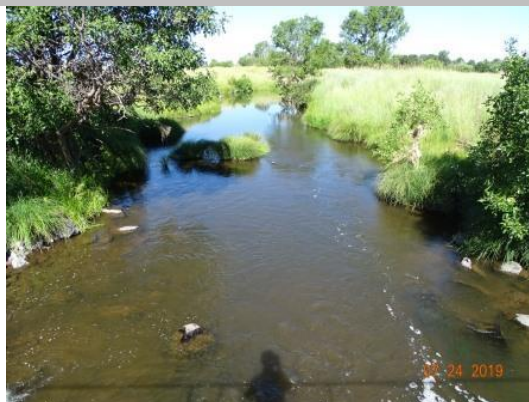
Photo 1 of 1 : CH_2019_NA0030_1_36_20190726_00013.jpg

| Inspector Comments: The channel is clear of vegetation & obstructions. | | | | |

Downstream view of Ash Creek from the weir.

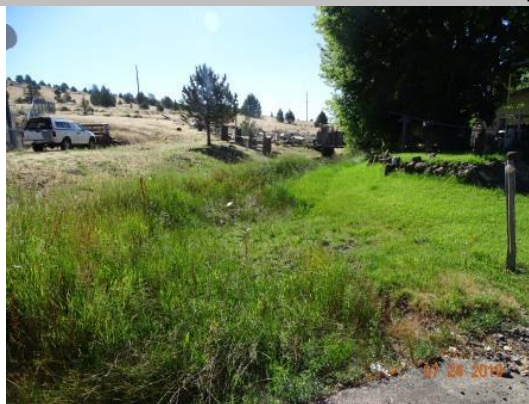
Photo 1 of 1 : CH_2019_NA0030_2_1_20190726_00005.jpg

Upstream view of the Dry Creek from Adin Street.

| Inspector Comments: Keep vegetation in channel trimmed and low to the ground. | | | | |

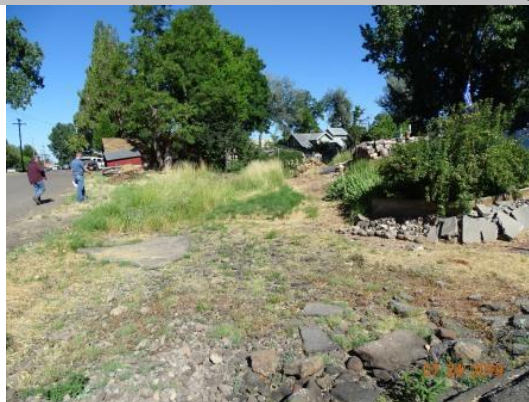
Photo 1 of 1 : CH_2019_NA0030_2_6_20190726_00006.jpg

Downstream view of Dry Creek from Adin Street.

| Inspector Comments: Peform vegetation management in channel. | | | | |

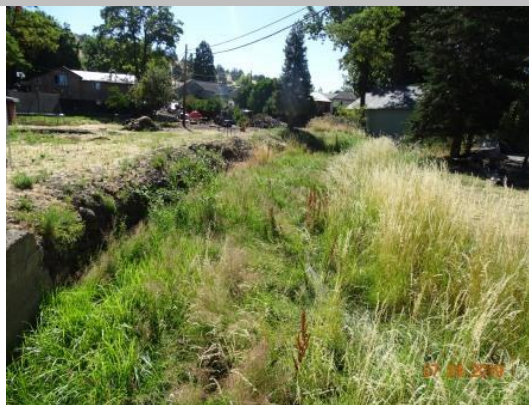
Photo 1 of 1 : CH_2019_NA0030_2_11_20190726_00007.jpg

Upstream view of Dry Creek from Main Street.

| Inspector Comments: Perform vegetation management in channel. | | | | |

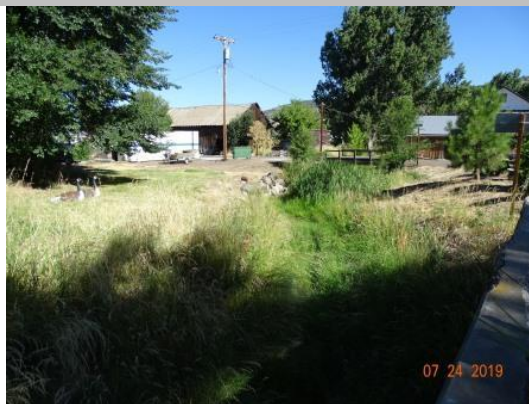
Photo 1 of 1 : CH_2019_NA0030_2_16_20190726_00008.jpg

Downstream view of Dry Creek from Main Street.

| Inspector Comments: Perform vegetation management within the channel. | | | | |
